# 1923 - 1925 Lycoming CE engine Oil Pump Replacement

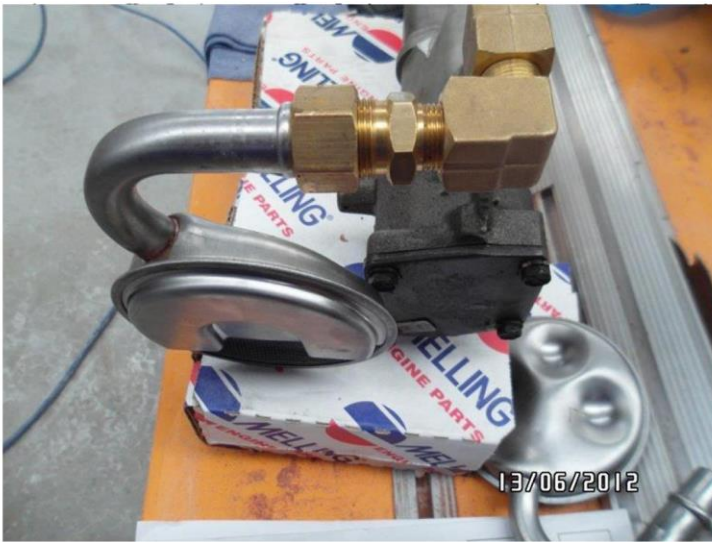
The screen bolted up using the brass fittings

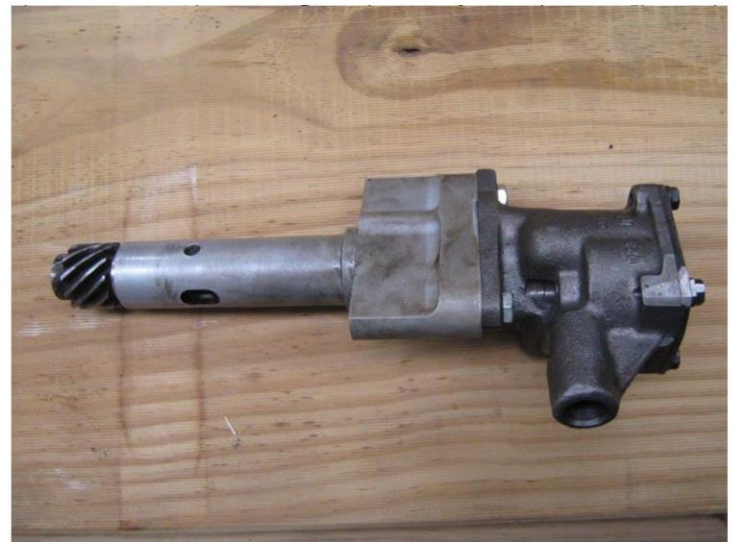
The pump bolted up to the adaptor

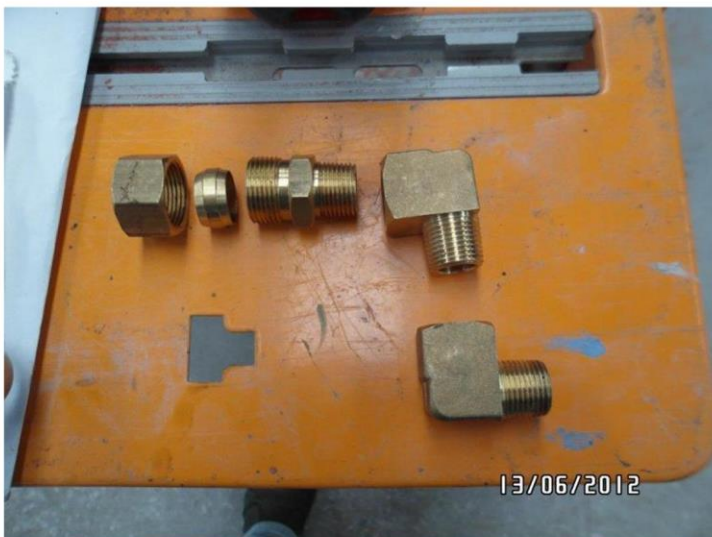
The fittings used

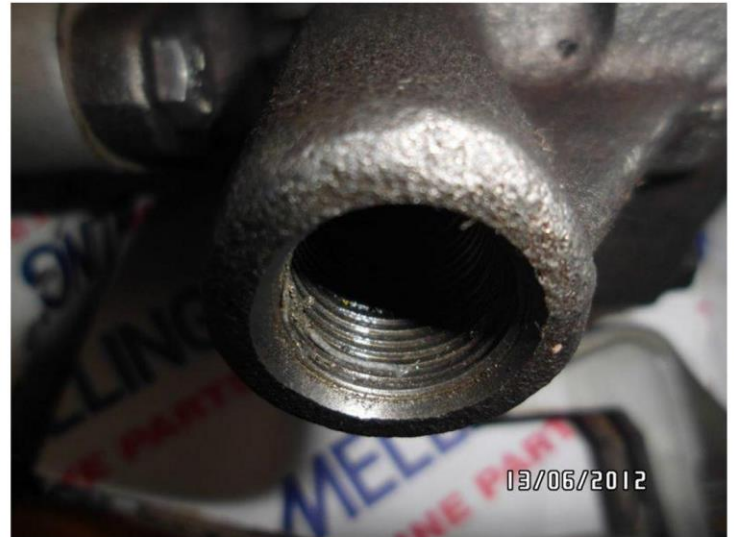
You have to run a tap into the M62 inlet to take the fittings

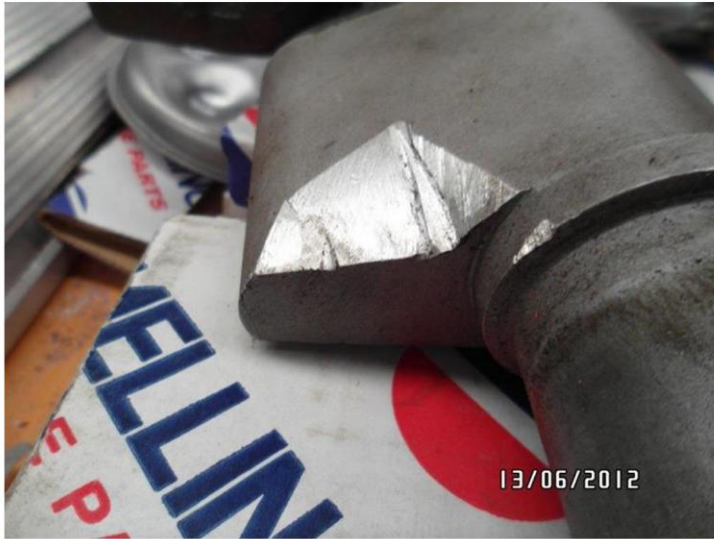
You need to remove the edge for crankshaft clearance

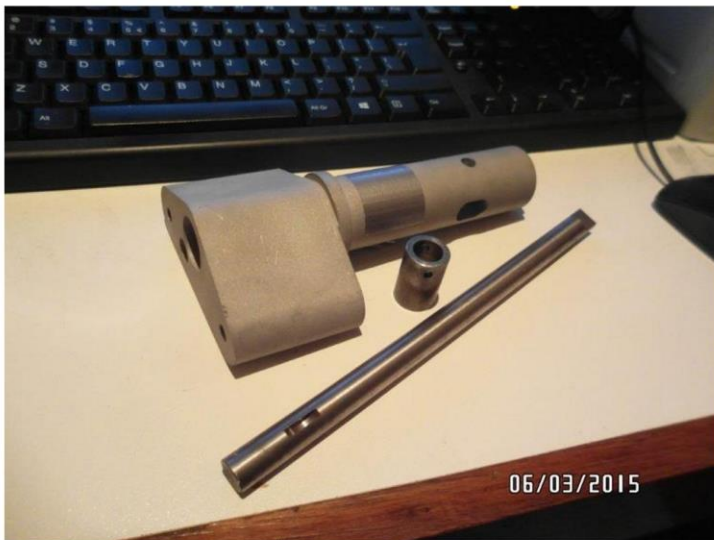
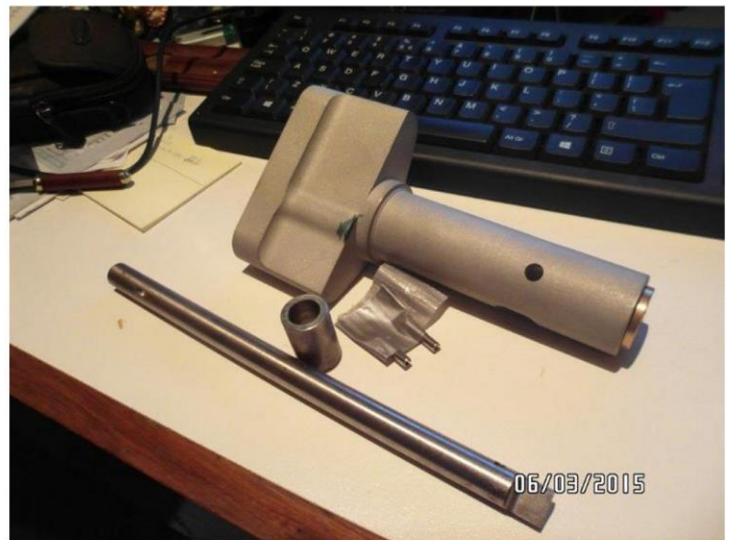
Above adaptor/shaft and top spacer shown

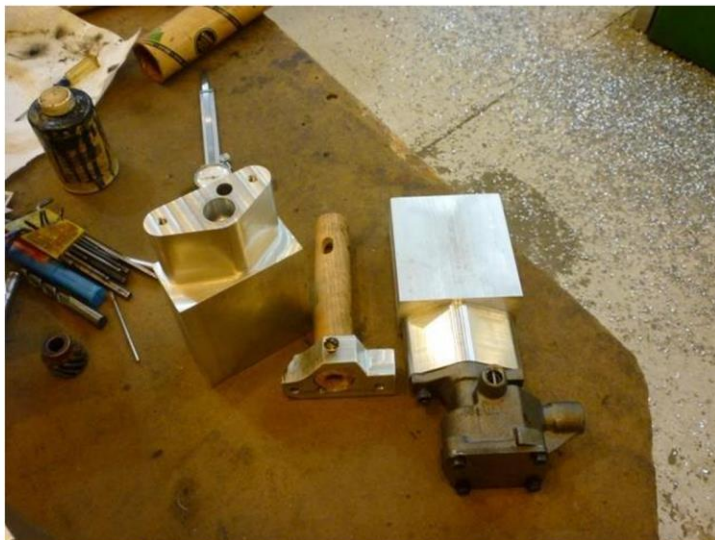
Left: Start of the process

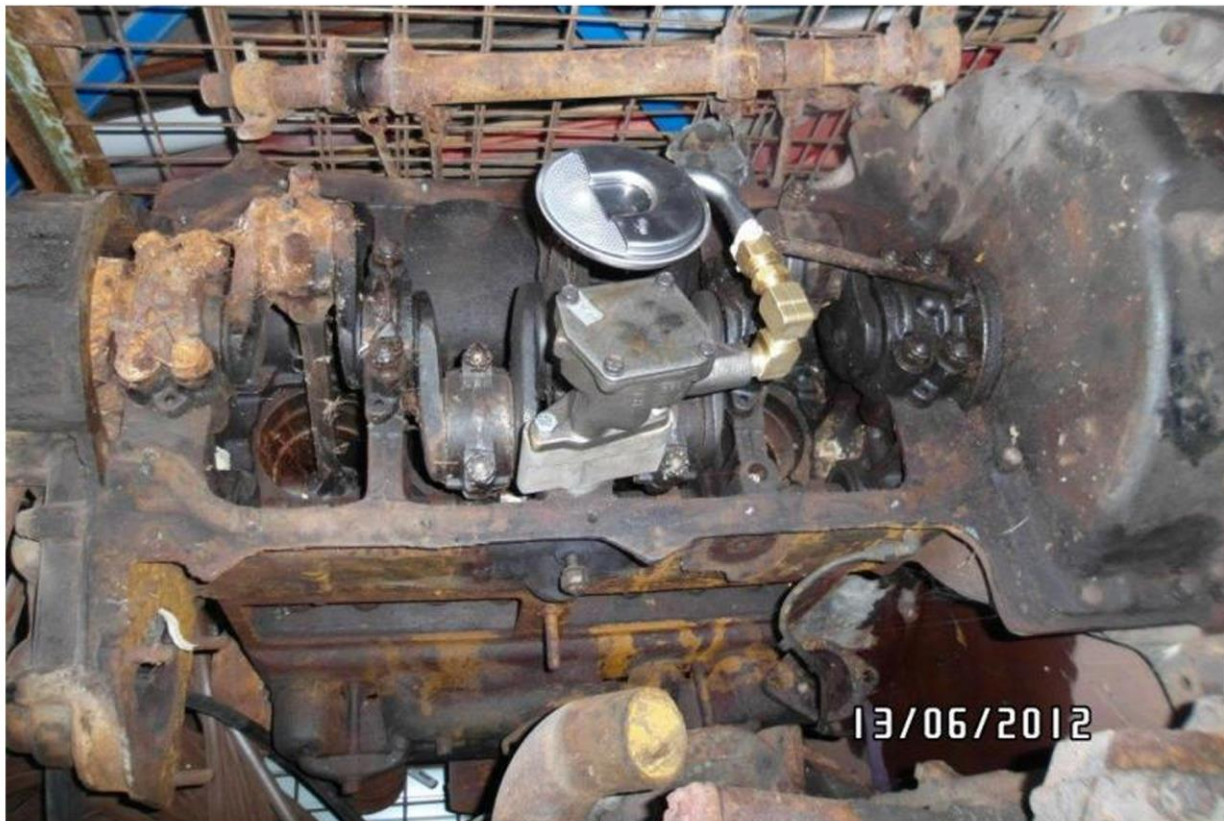
Once fitted the oil pan/sump hits just on the side of the pump.  
You need to just tap/hit out the side of the oil pan/sump just to clear it.  
Special THANKS to Trevor Davis - Melbourne Australia  
for photos and guidance.
